STATE OF CALIFORNIA
DEPARTMENT OF WATER RESOURCES
DIVISION OF RESOURCES PLANNING

BULLETIN NO. 81

INTRUSION OF SALT WATER
INTO GROUND WATER BASINS OF
SOUTHERN ALAMEDA COUNTY

December 1960

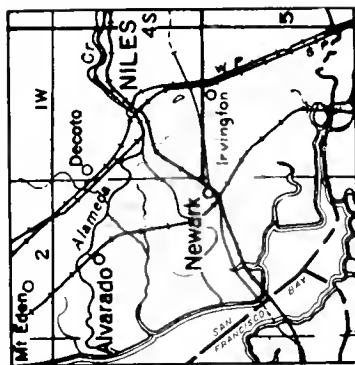
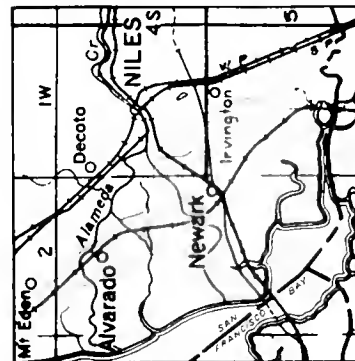
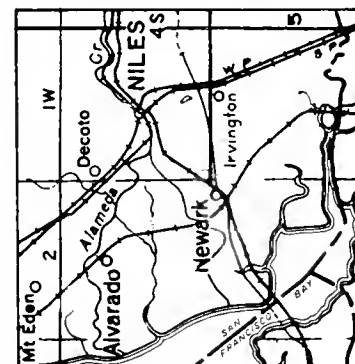
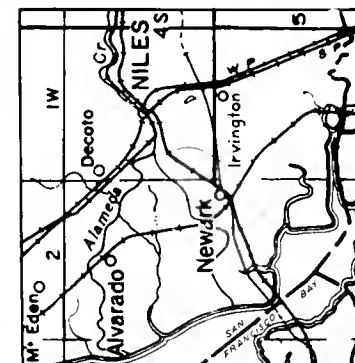
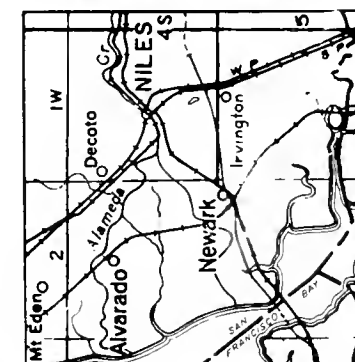
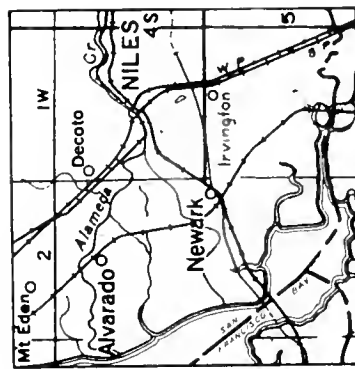
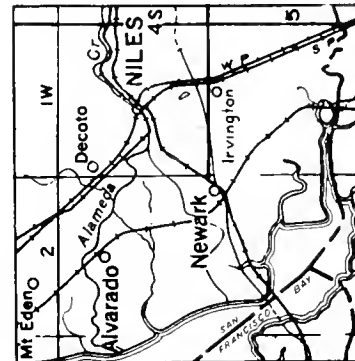
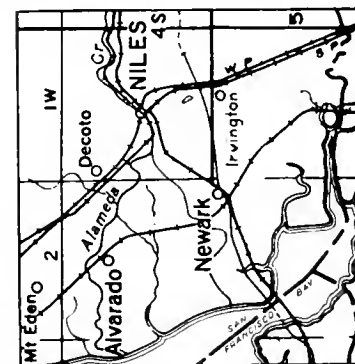
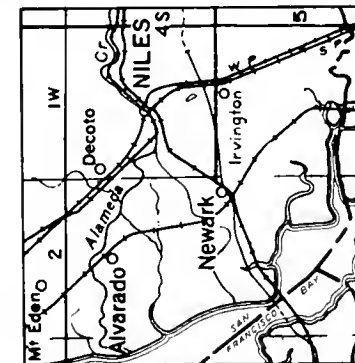
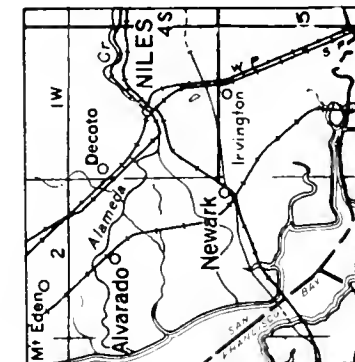
DEGRADATION OF SHALLOW (NEWARK AQUIFER) AND DEEP (CENTERVILLE AQUIFER) GROUND WATER

During the six-year period from 1936 to 1942, there was a moderate improvement in the quality of water from shallow wells, probably due to effects of above normal rainfall. In 1950, and again in 1957, however, it was found that bay water had intruded further inland in the Niles cone area. The progressive degradation of waters in the Newark aquifer is illustrated on Figure 1.

INDICATES WATERS WITH CHLORIDE CONCENTRATIONS EXCEEDING 350 PPM

deep wells in the vicinity of Newark and Alvarado were reported to be yielding salt water. By the end of 1950, about 100 acres of the Centerville aquifer produced water with chloride concentrations in excess of 350 ppm; this area of degraded water increased to about 230 acres early in 1951.

Information collected by the Department of Water Resources during a county-wide water resources investigation indicated that 660 acres of the Centerville aquifer were degraded by salt-water intrusion during the winter of 1953-54 (27). A few years later, in 1956, a reconnaissance survey indicated an alarming increase in the area affected (19).

By late 1958, about 2,630 acres of the Centerville aquifer were affected (Plate 6). Samples collected during 1959 show that about 3,000 acres were degraded by salt water.

The foregoing observations, summarized on Figure 1, clearly show a progressive increase in the area of degraded water in the Centerville aquifer.

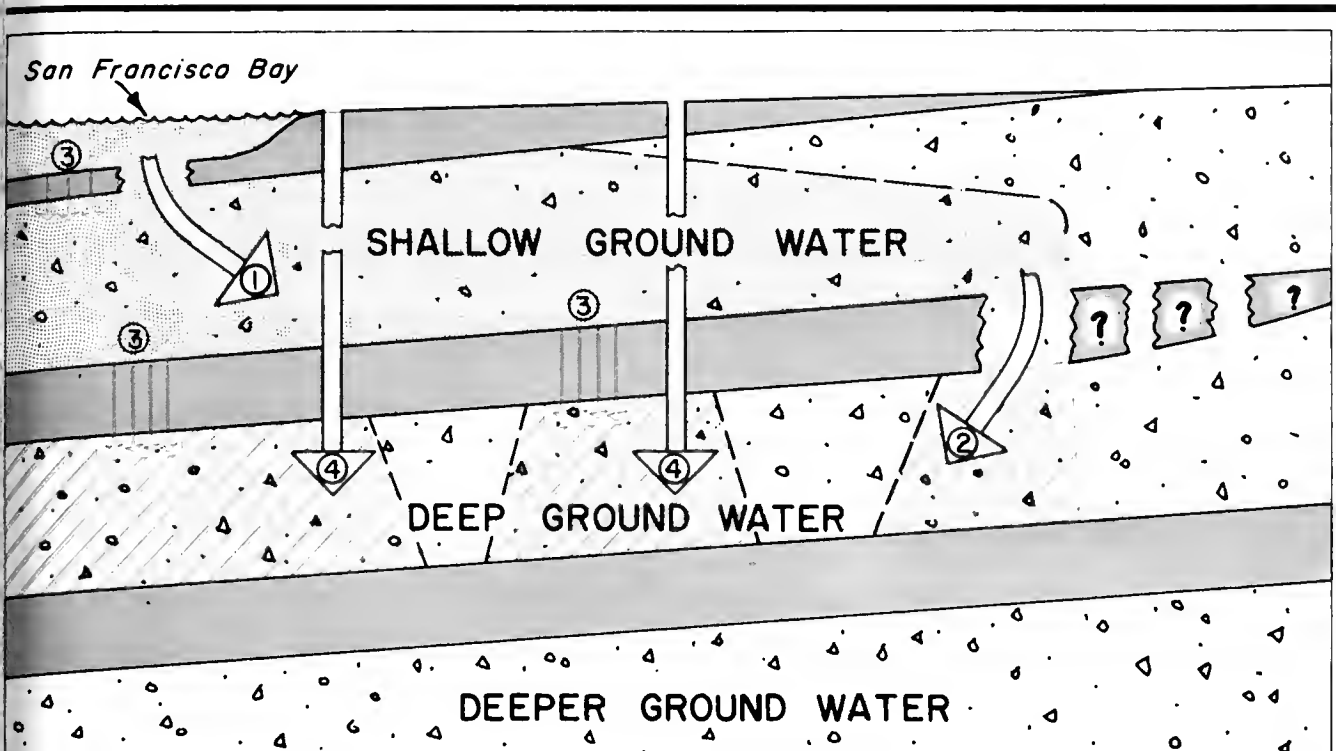
Possible means for entry of salt water into ground waters are delineated on Figure 2. It is seen that there are three natural routes for subsurface movement of salt water into ground-water reservoirs. The one man-made route permits leaking or cascading of saline surface or ground water through wells. The shallow ground-water reservoir corresponds to the Newark aquifer and the deeper reservoirs correspond to the Centerville and Fremont aquifers.

1. Direct movement of bay waters through natural "windows".
2. Spilling of degraded ground waters.
3. Slow percolation of salt water through reservoir roof.
4. Spilling or cascading of saline surface waters or degraded ground water through wells.

1. Spilling of degraded ground waters over the inland edge of the clay layer separating the Newark and Centerville aquifers.
2. Percolation of degraded ground waters through the clay layer separating the Newark and Centerville aquifers.
3. Leaking or cascading of saline surface or degraded ground waters through wells.

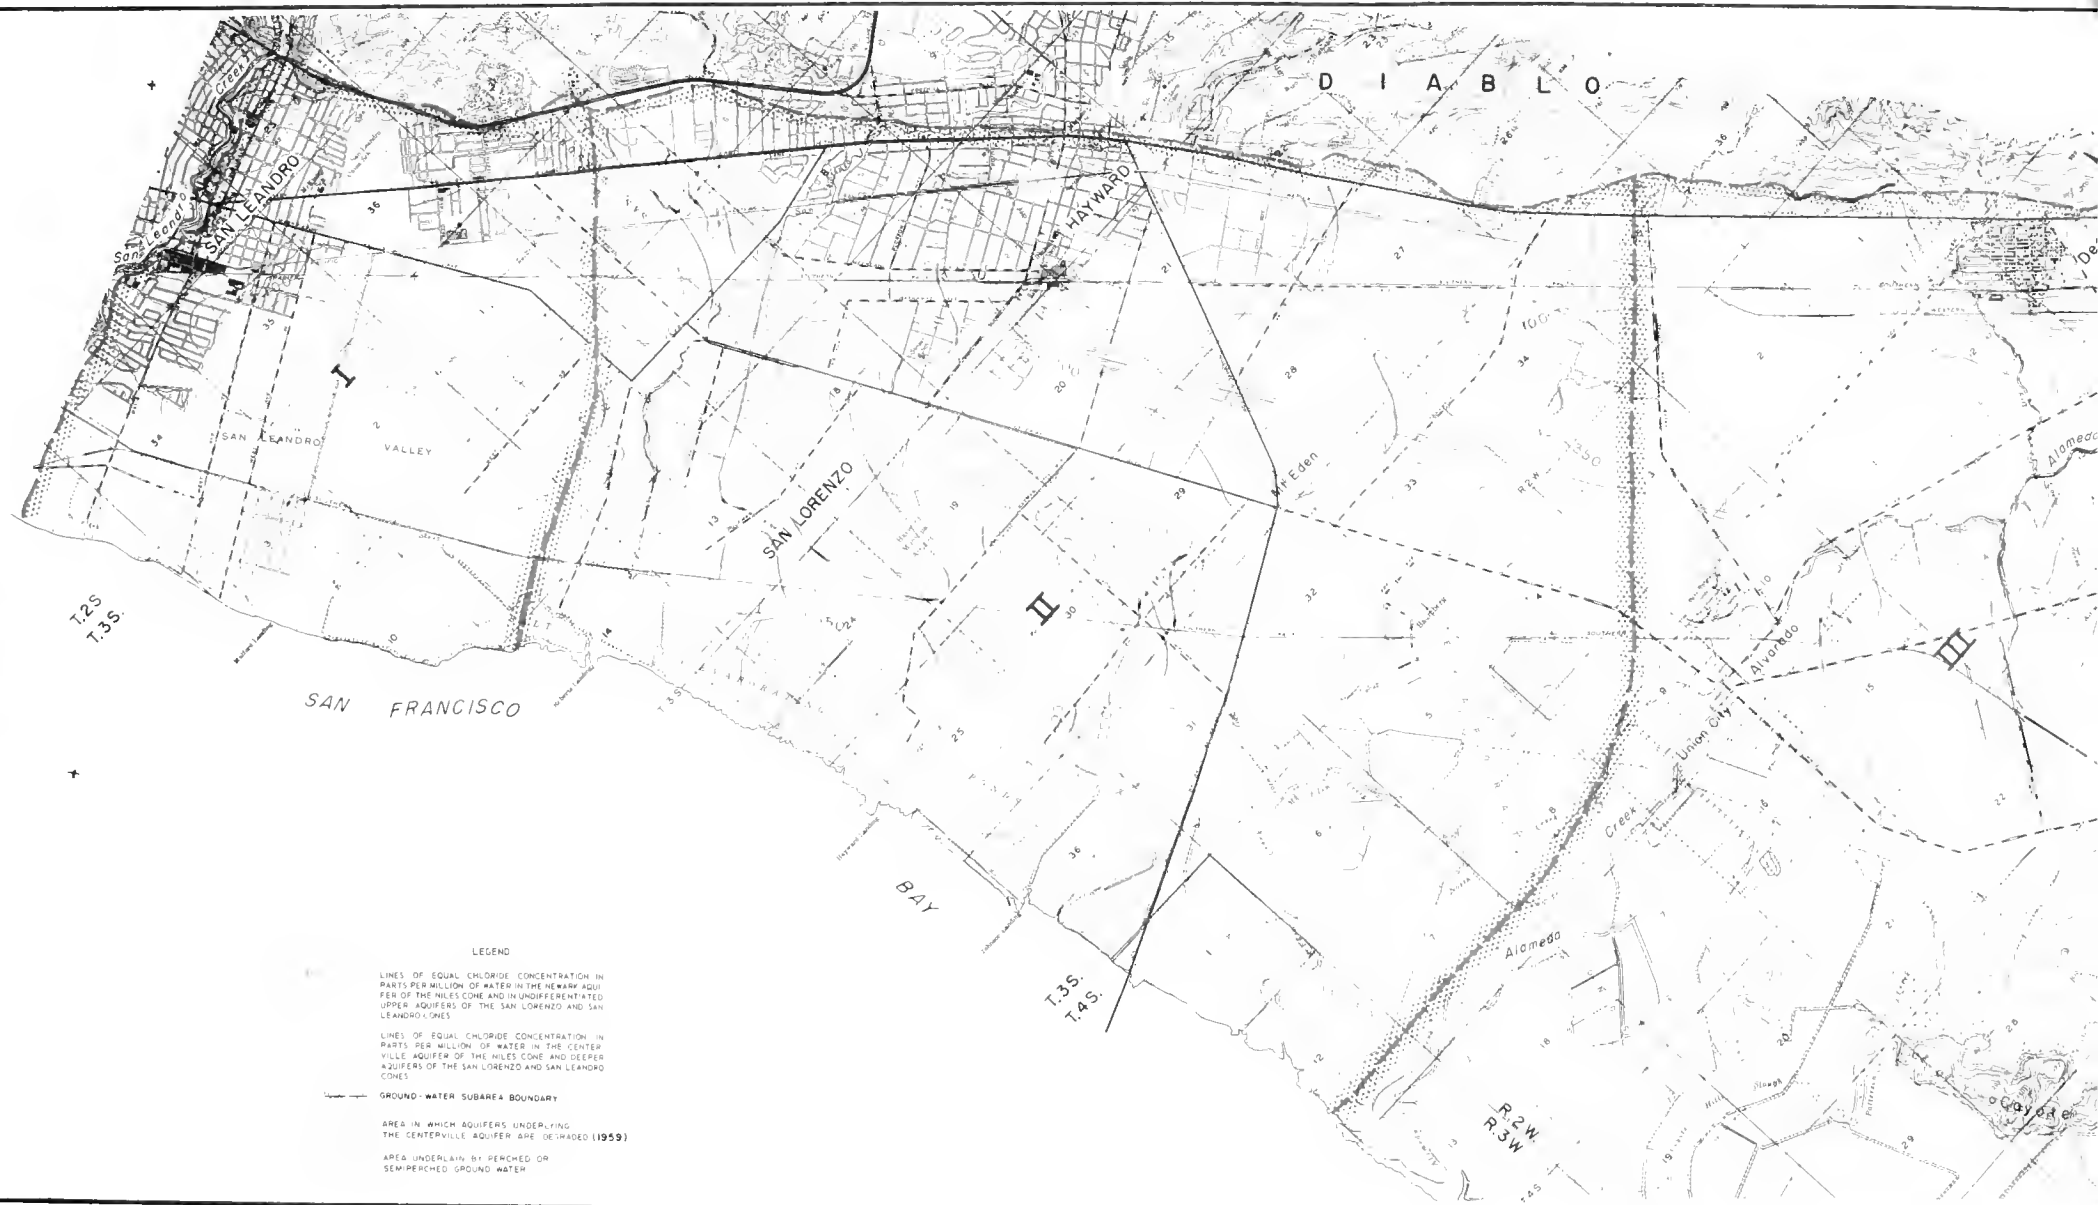
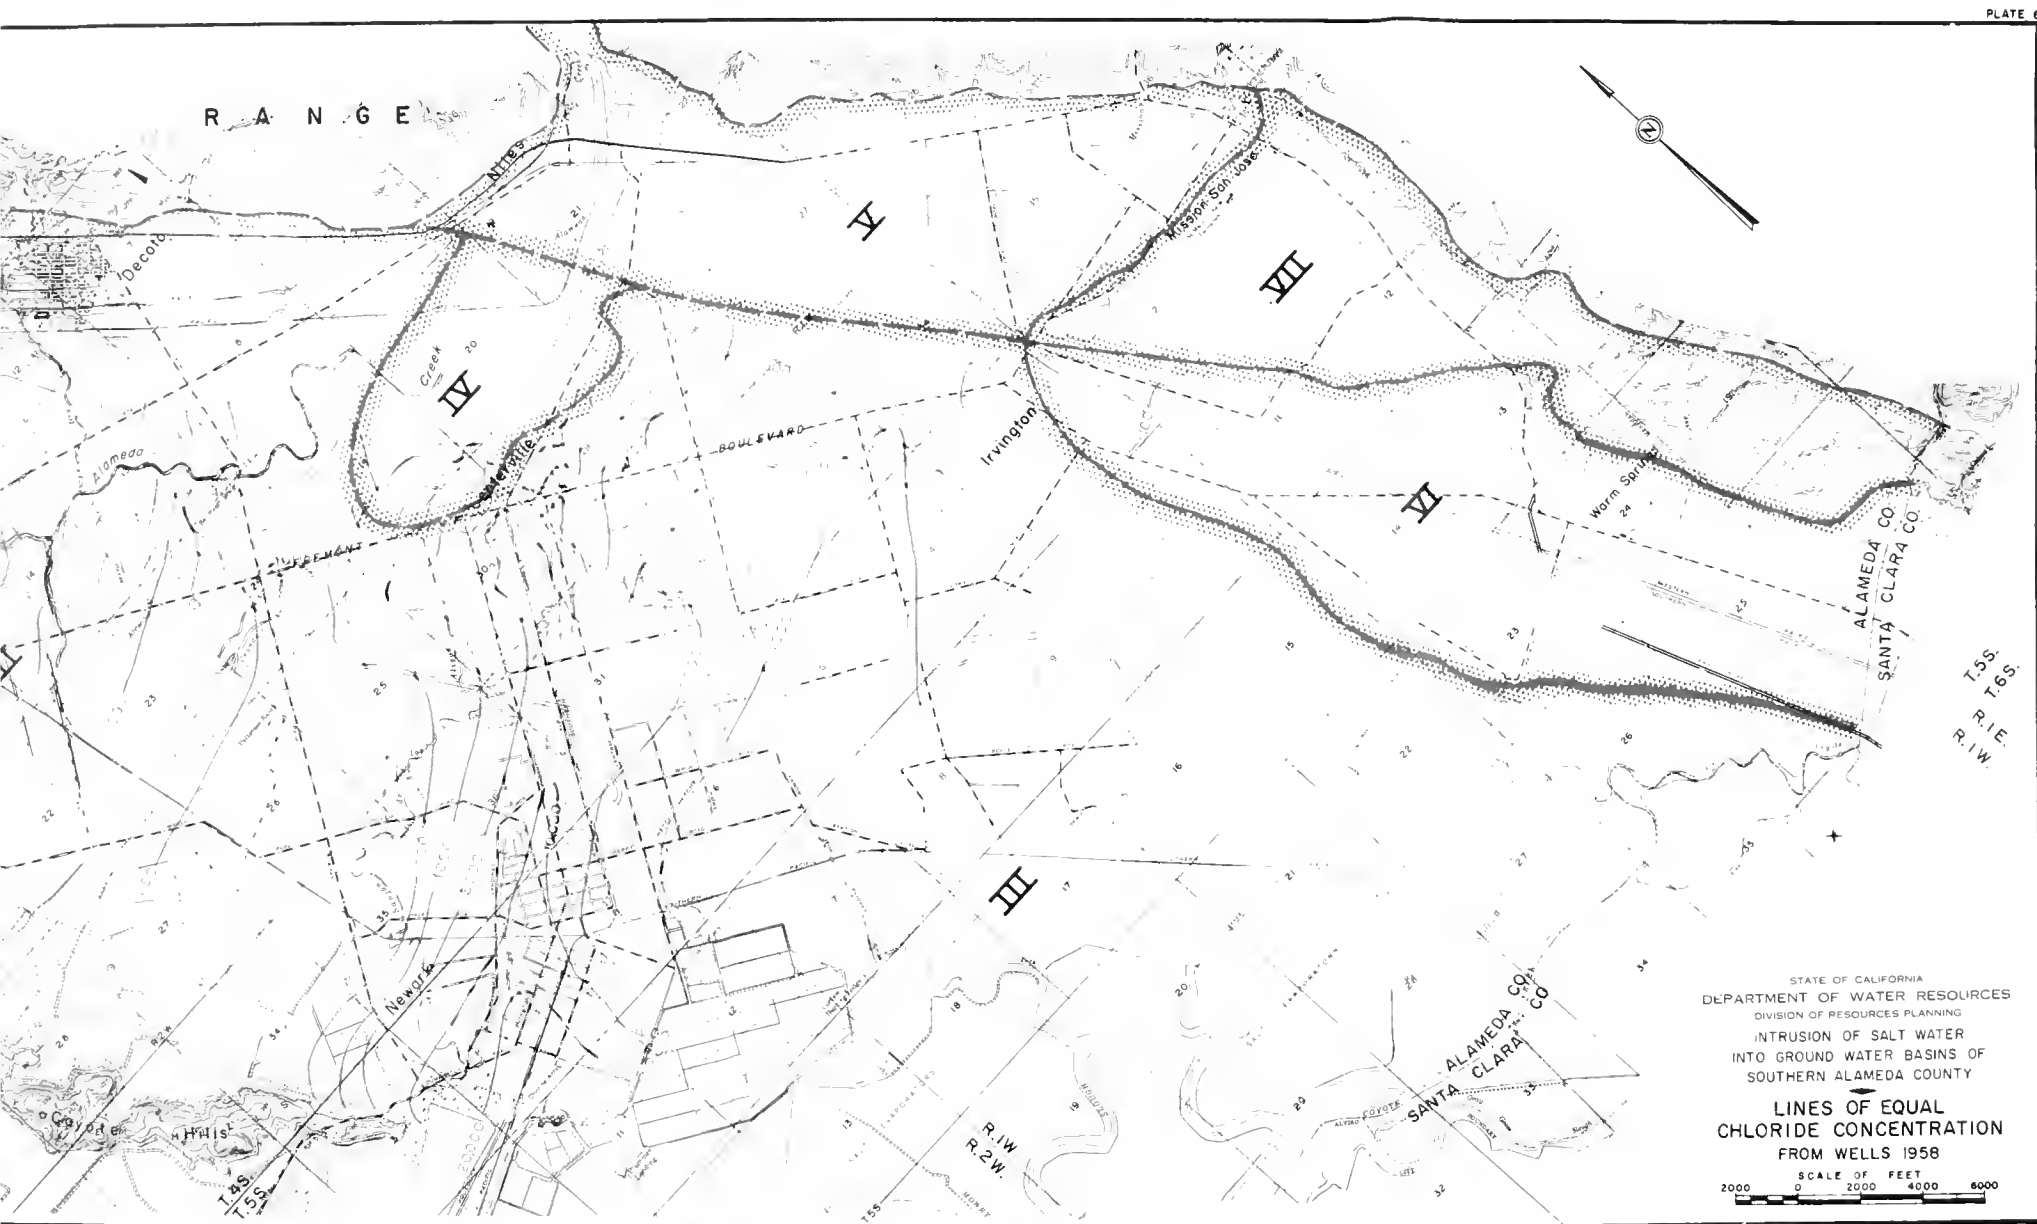
LINES OF EQUAL
CHLORIDE CONCENTRATION
FROM WELLS 1958

Plate 6 shows an isolated area in the vicinity of Alvarado and Newark where water of the Fremont aquifer was found to be degraded in 1959. It is important to note that degradation of this aquifer has begun.

Spill Over Inland Edge of Confining Clay Layer. The area affected by salt-water intrusion in the Centerville aquifer, as shown on Plate 6, extends inland to the vicinity of Fremont Boulevard. If this degradation were caused by spill of saline waters from the Newark aquifer over the inland edge of the separating clay layer, it could be postulated that the clay layer should end in this vicinity. To test this hypothesis, an investigation was conducted to determine whether the clay layer was present in this area.

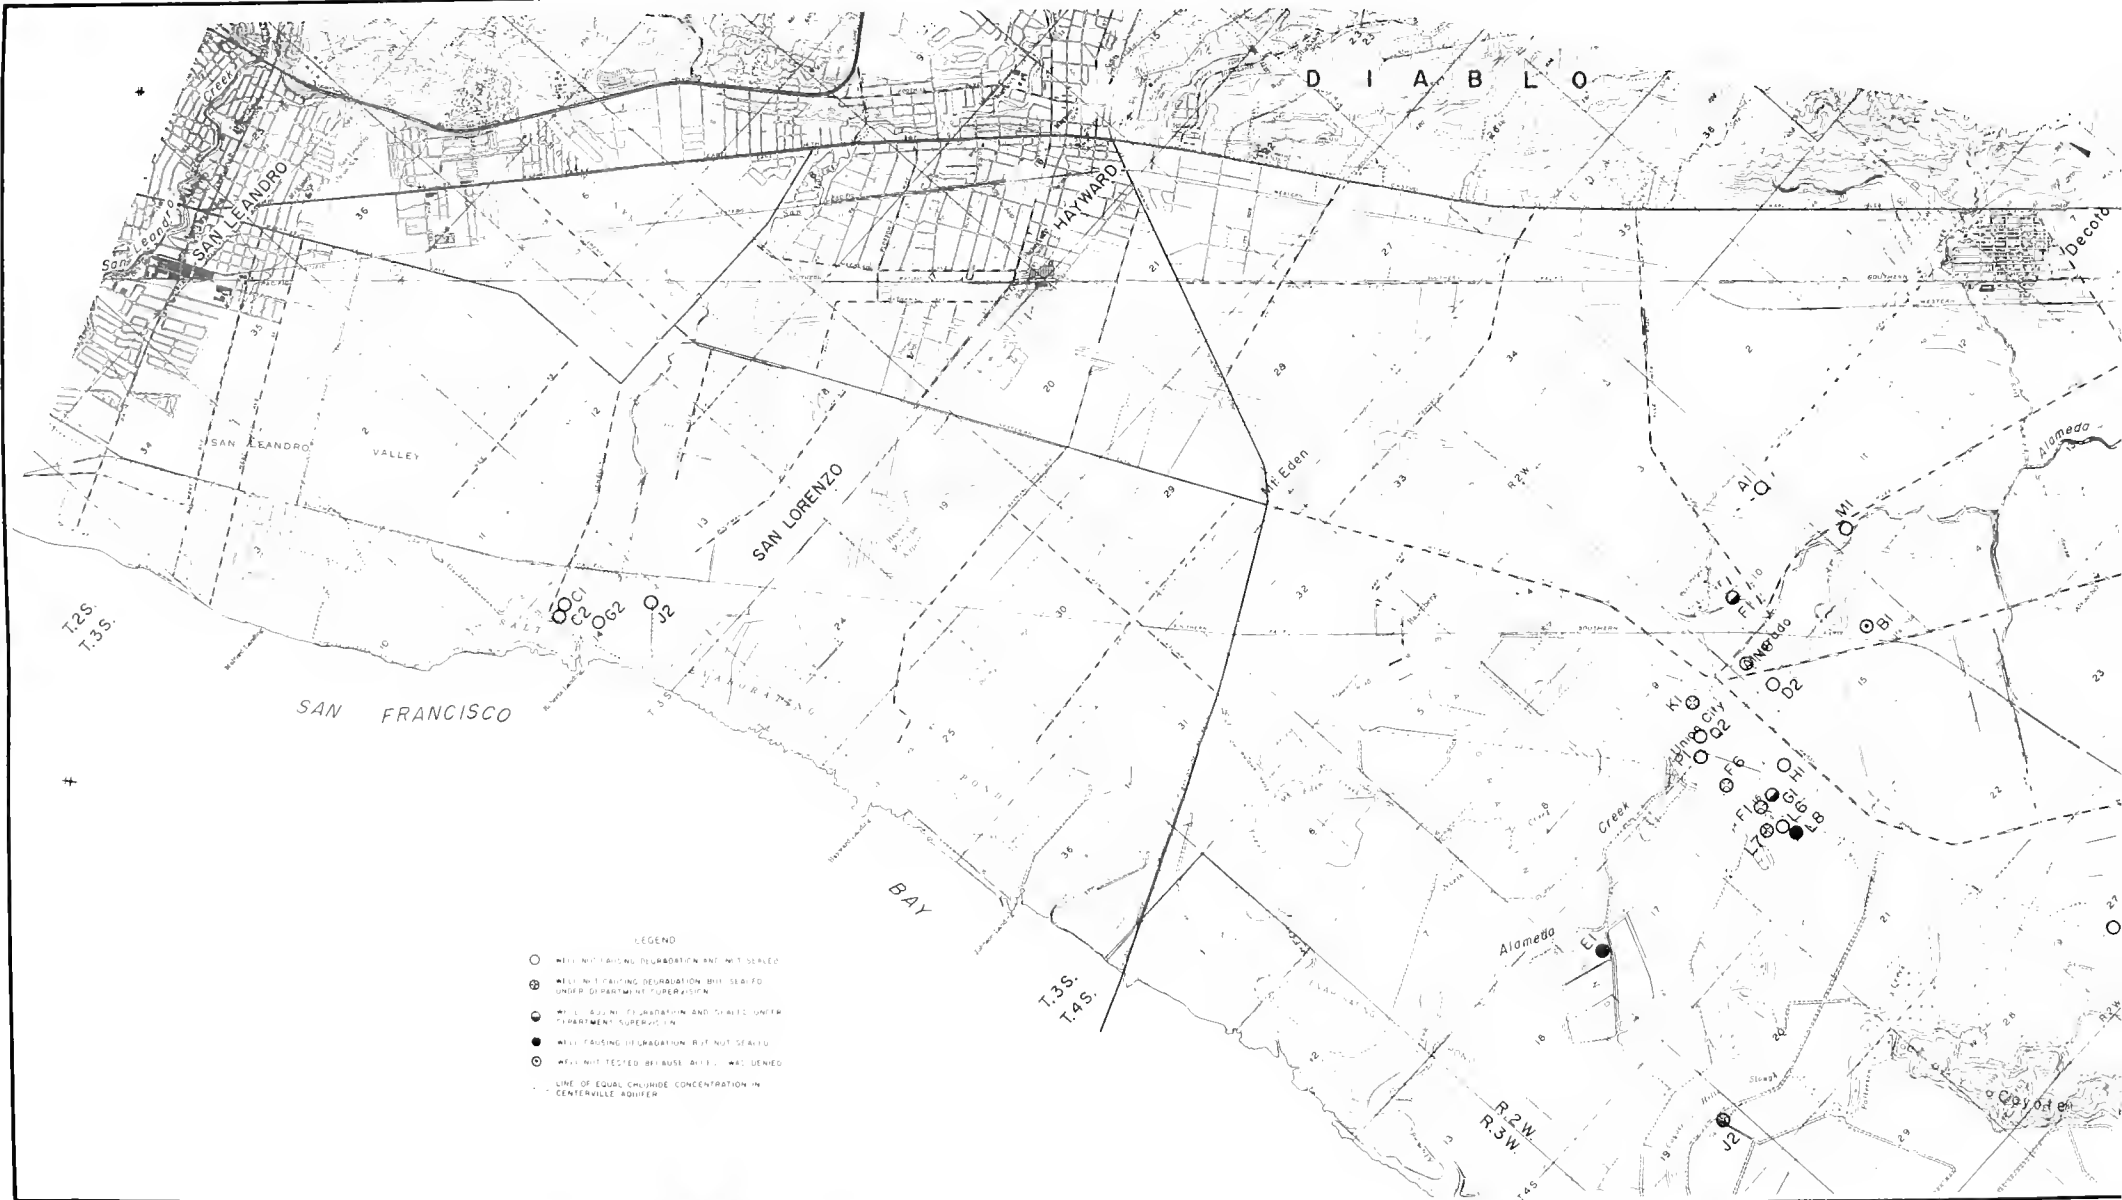
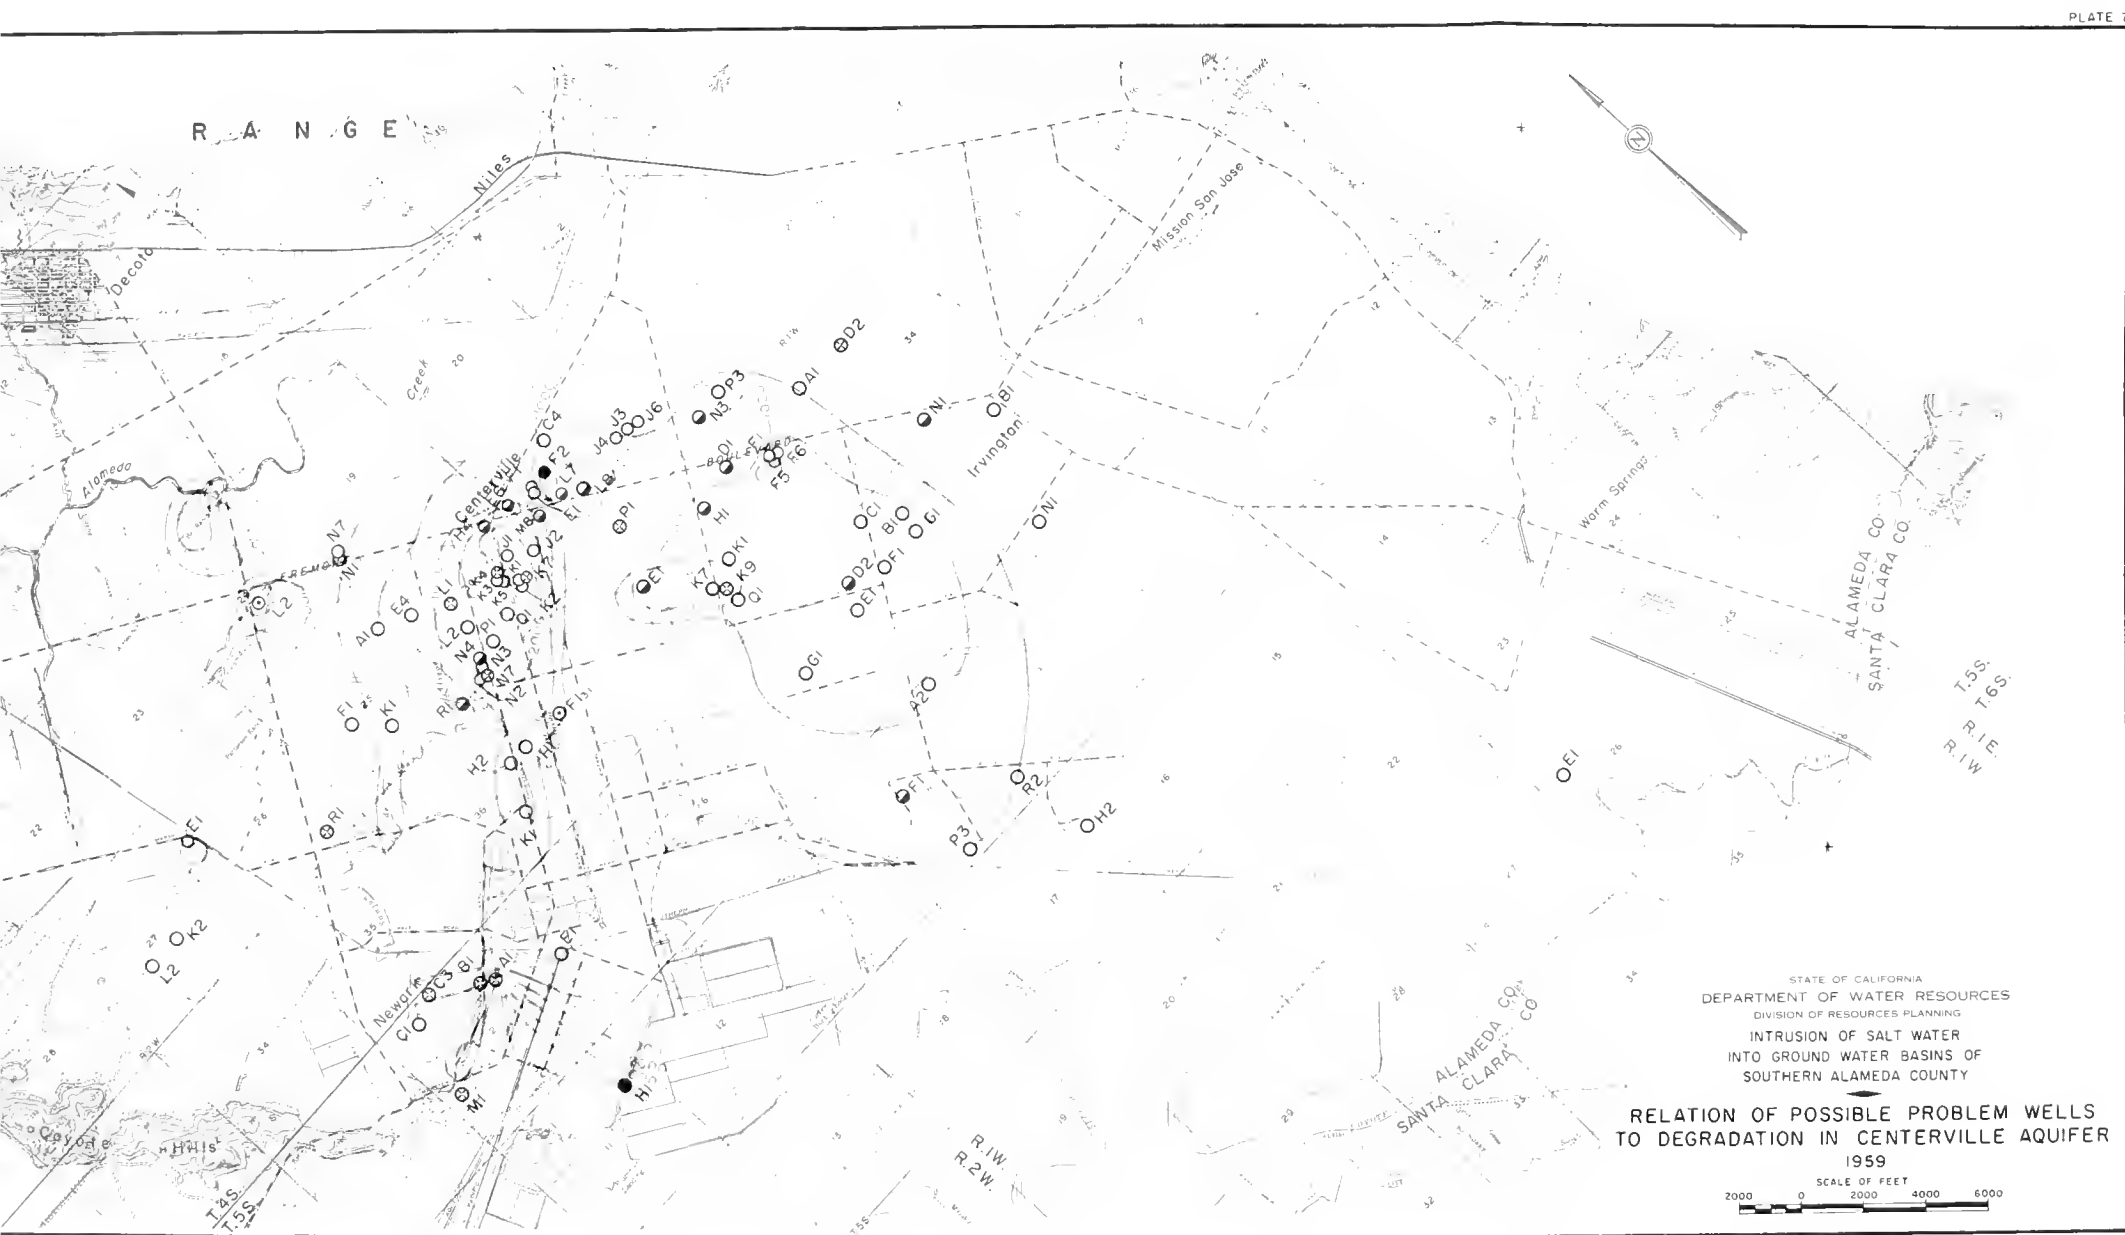
RELATION OF POSSIBLE PROBLEM WELLS
TO DEGRADATION IN CENTERVILLE AQUIFER
1959

During the course of the investigation, 100 wells thought to be contributing to the problem of water-quality degradation were subjected to detailed tests. Twenty of these wells were found to be contributing to the water-quality problem by allowing interchange of water between various gravel strata. Sixteen of these defective wells were sealed or repaired by the owners under our supervision; information concerning the remaining four wells has been referred to the San Francisco Bay Regional Water Pollution Control Board (No. 2).
